CULTURAL RECONNAISSANCE OF
ROCK BORROW AREAS NEAR KEKAHA, KAUA'I, HAWAII

Aki Sinoto

Department of Anthropology
Bernice P. Bishop Museum

U.S. Army Engineer District, Pacific Ocean
Honolulu, Hawaii

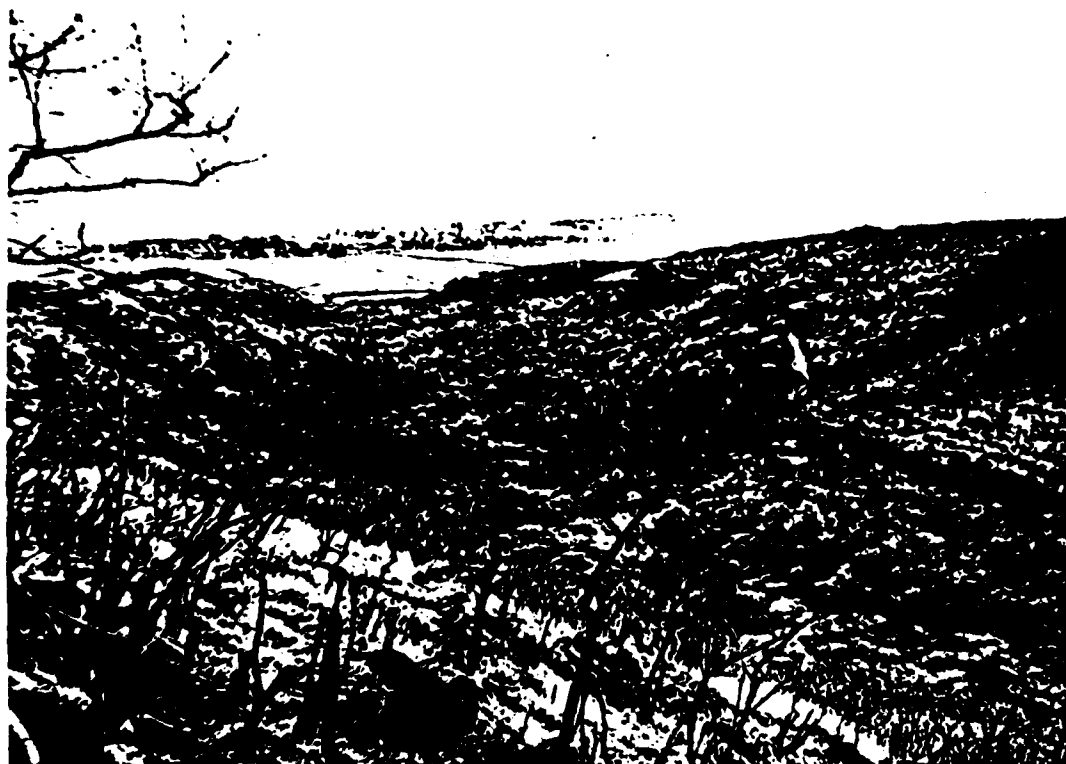
Fig. 4. OVERVIEW OF WAIKA VALLEY, FROM NORTH.

This valley was surveyed from its mouth to approximately 4,300 ft inland. Cattle are kept here, and the generally disturbed conditions are similar to Kapilimao. A bulldozed road leads up the valley to the irrigation siphon, following along the western bank of the main stream bed. Two sites were located in the central portion of the survey area (see Fig. 1).

The remaining portions of the valley, within the area surveyed, were found to be lacking in remains, and are archaeologically cleared for borrow activities.

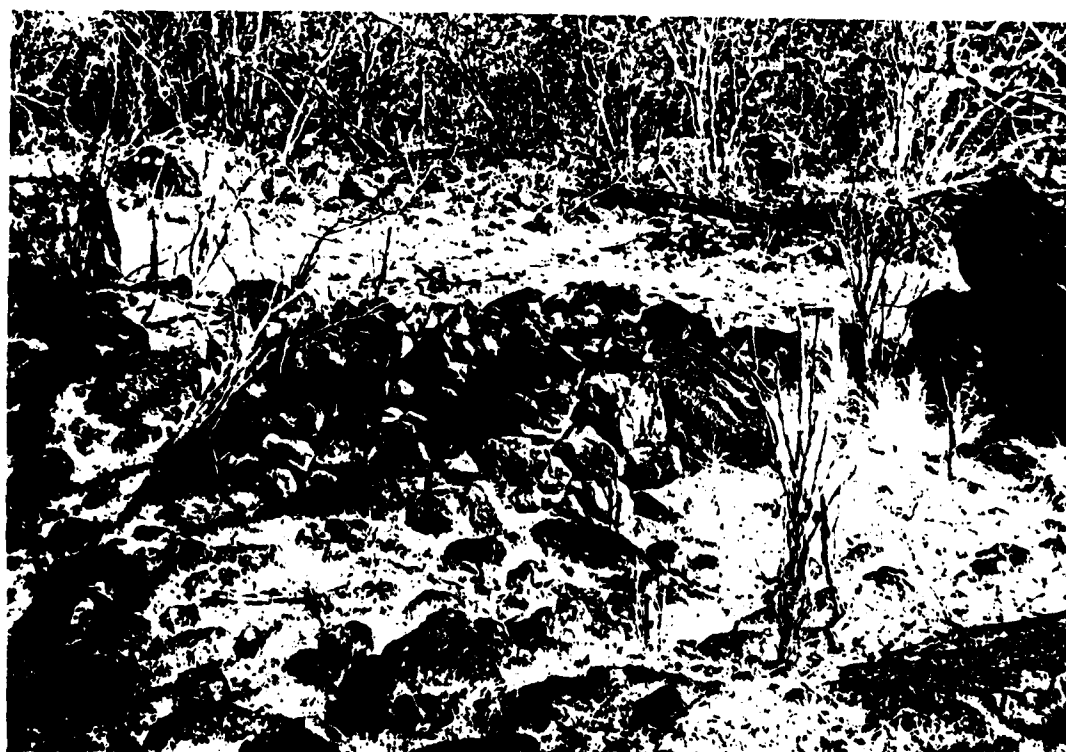
Fig. 5. RECTANGULAR CAIRN, SITE 1 IN WAIKA VALLEY.
View from west.

Site 1 is a rectangular stone cairn constructed of basalt rock and rubble (Fig. 5), located approximately 20 meters west of the bulldozed road. It measures

2.2 meters long by 2 meters wide and .80 meter in height. Of undetermined function, it may mark a grave.

Both Sites 1 and 2 have been marked with pink flagging tape so as to be readily visible during the borrow activities. A buffer zone of at least 10 meters surrounding these sites is recommended.

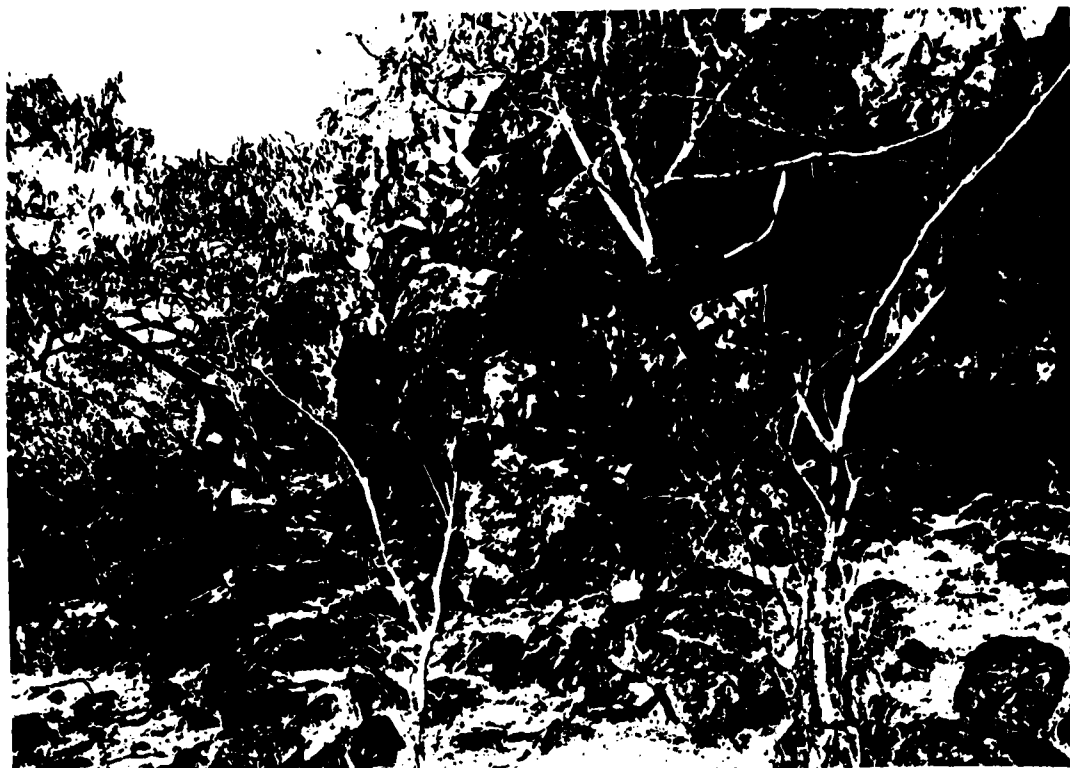
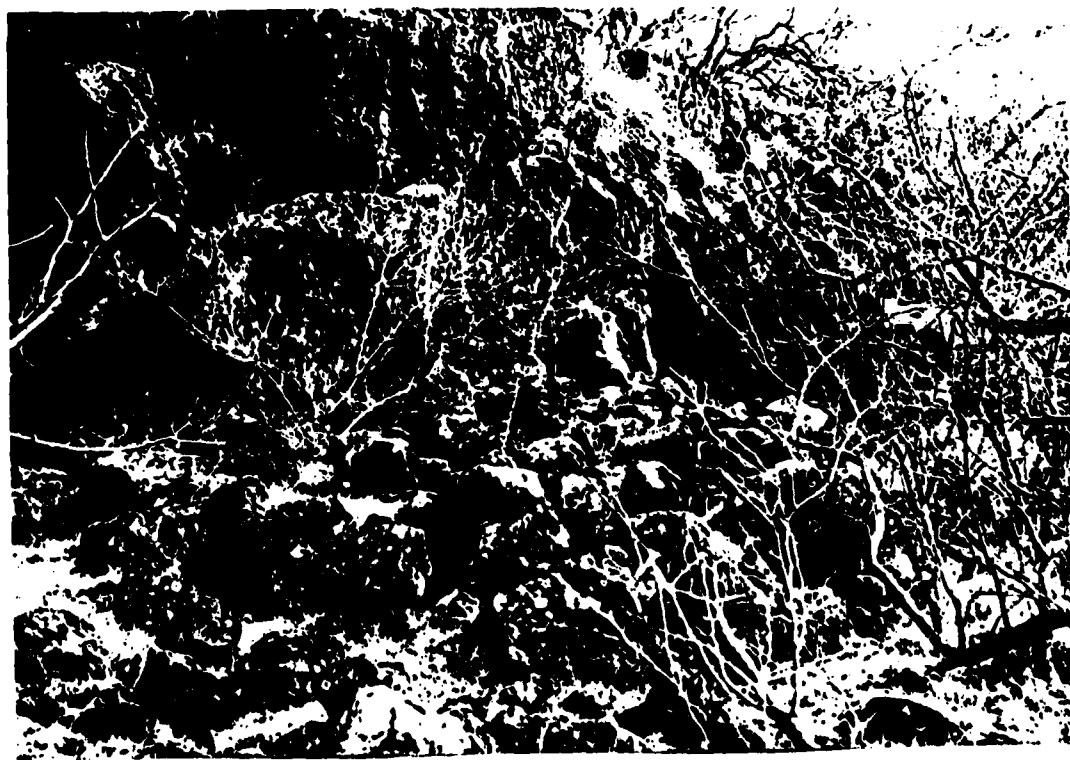
Fig. 6. MODIFIED SHELTERS, SITE 2 IN WAIAKA VALLEY.

Site 2 is a series of small overhang shelters located at the foot of a cliff across the stream bed and approximately 50 meters east of Site 1. The fronting areas are modified with stone walls, terracing, and a platform (Fig. 6).

a. View from southwest

b. View from northwest

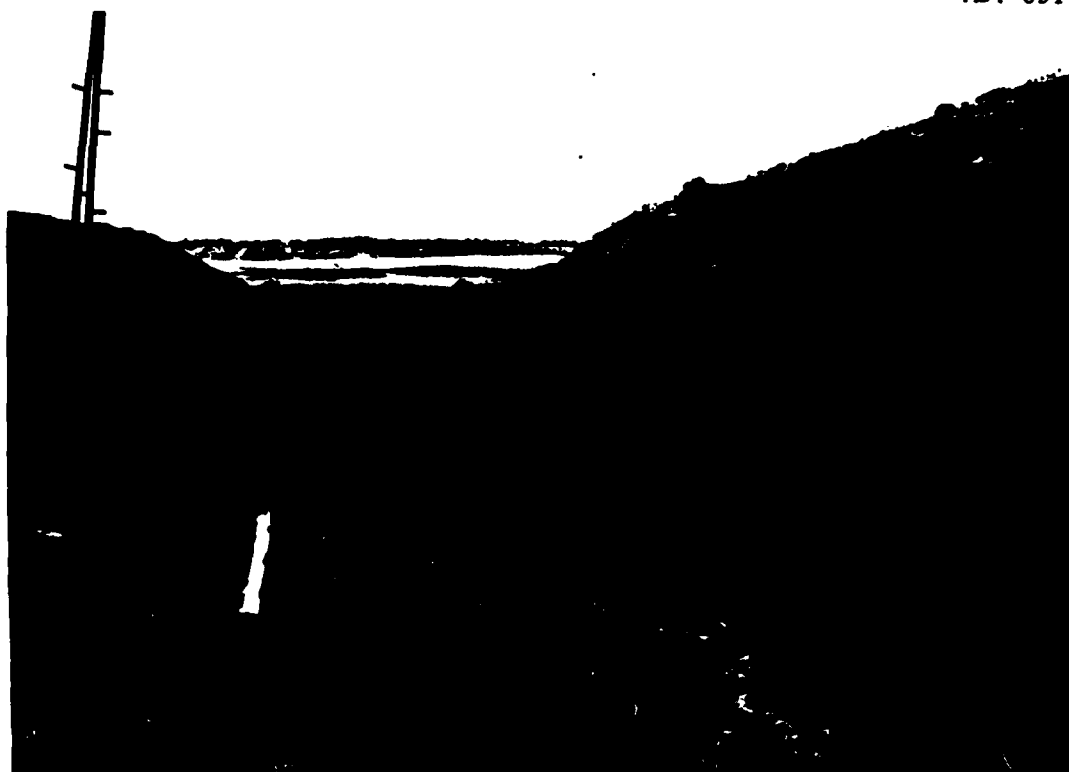
Fig. 8. OVERVIEW OF WAIPAO VALLEY.
View from Kōke'e Road on the north.

The southern portion of this valley has been extensively bulldozed and was previously planted in sugarcane (Ching, personal communication). Kōke'e Road runs inland along the eastern slope of the valley and constitutes the eastern limit of the survey. Cattle are kept in portions of the valley, west of the main stream bed to the pumping station at the upper end of the survey area, 5,000 ft inland. A few sites, including crude terracing, stone piles, and an apparent cattle wall (Fig. 9), were located in the northern portions of the valley.

The area immediately south of the pumping station, comprising about a third of the survey area, is restricted from borrowing activities (see Fig. 1).

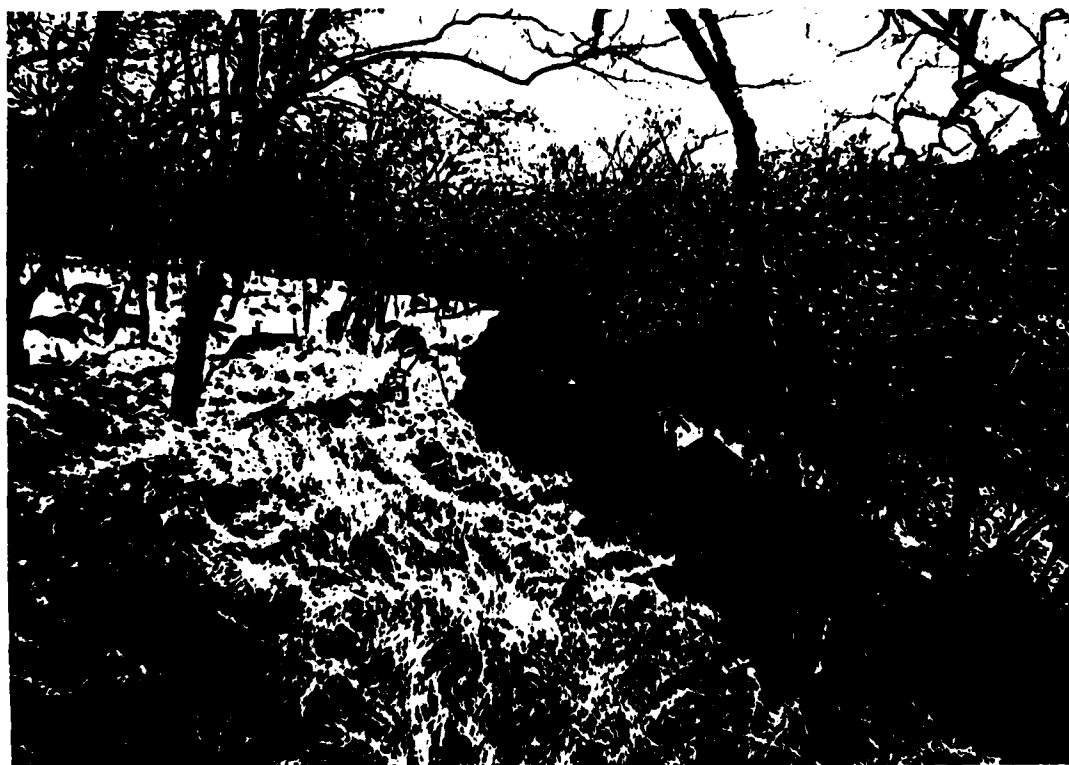
Fig. 9. CATTLE WALL IN WAIPAO VALLEY.
View from north.

The southern limit of the restricted area is readily apparent because the cattle wall traverses this portion of the valley. The wall continues southward, paralleling the stream into the unrestricted area, but is clearly visible and should be avoided.

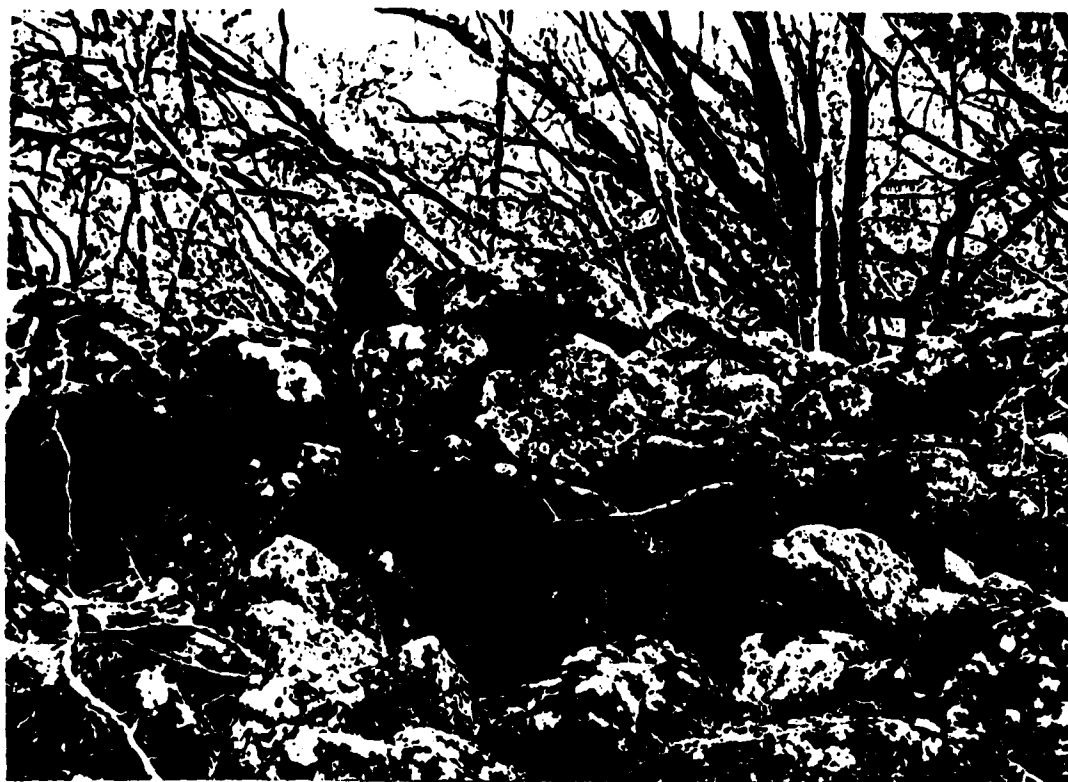
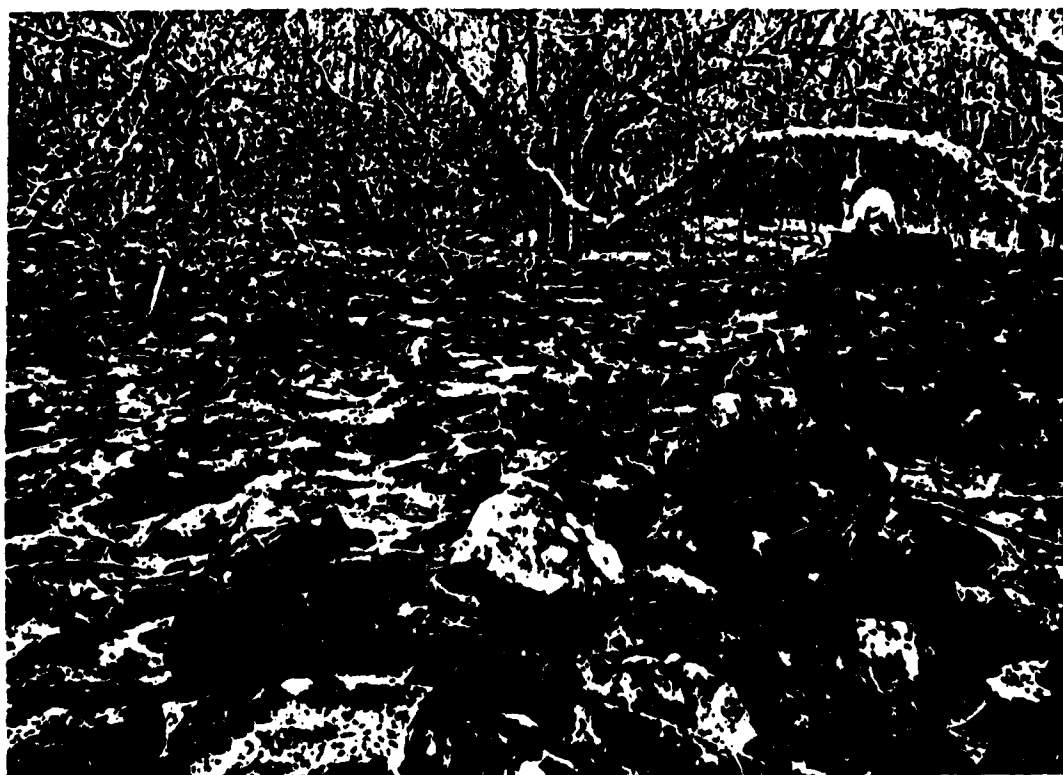
Fig. 11. HAUOLA HEIAU, SITE 50-Ka-C3-1, IN HO'EA VALLEY.

This valley exhibits the greatest potential for cultural resources of all the valleys surveyed. Hauola Heiau, Hawaii State Register site 50-30-5-16 (Bishop Museum Site 50-Ka-C3-1; Bennett site 16), designated "High Value," is located at the western foot of Hauola Ridge (see Fig. 1). This site is described in detail by Bennett (1931:36, 37, 44-48, 51, 103). The *heiau* survives in excellent condition (Fig. 11), although some recent disturbance from cattle and stream bank erosion were evident. This site definitely merits preservation and is an excellent candidate for proper restoration and public interpretation. For the present, however, efforts should be made to keep cattle out of the structure.

a. North wall with waterworn stone; view from south.

b. Pavement of upper platform; view from northwest.
